Simple, Low-Cost Vibration Monitoring of Air Handlers

By Doug Ausbon, Johnson Controls, Inc., and Tom LaRocque, CTC, Inc.

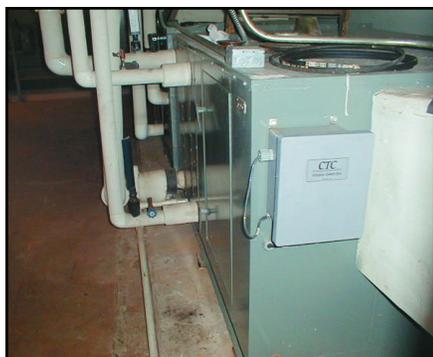
Figure 1 - Cables have been run from the accelerometers to a switchbox mounted outside of the enclosure.

In order to include enclosed air handling units in their vibration analysis program, accelerometers have been permanently mounted to fan and motor bearings, and cables have been run from the accelerometers to a switchbox mounted outside of the enclosure (Figure 1). This application has been successfully implemented for over 160 air handling units, serving a wide range of laboratory, manufacturing, and critical warehousing spaces. The majority of the air handling units monitored are belt driven. Data collection performed on monthly routes yields many indications of wear, including bearing degradation, sheave wear, misalignment, belt condition, and the build up of debris on fan blades.

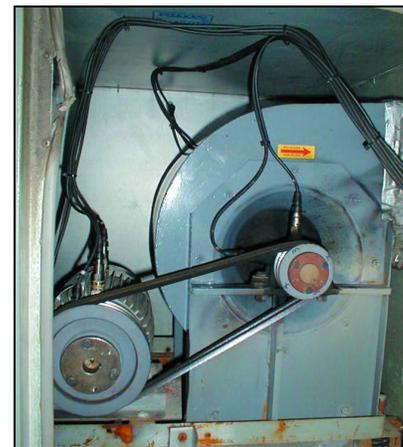
Figure 2 - The air handling units have fairly typical rotating elements, composed of two shafts supported by rolling element bearings, connected by a sheave-and-belt combination.

The air handling units have fairly typical rotating elements, composed of two shafts supported by rolling element bearings, connected by a

sheave-and-belt combination (Figure 2). Most are mounted on a spring support system. Expected failure modes requiring monitoring include:

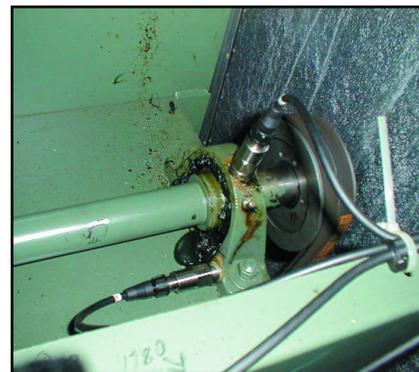
Figure 3 - To provide the optimum vibration transfer between the machine surface and the accelerometer, a mounting system that utilizes the full frequency span of the accelerometer needed to be considered.

To provide the optimum vibration transfer between the machine surface and the accelerometer, a mounting system that utilizes the full frequency span of the accelerometer needed to be considered (Figure 3). A mounting target attached to the prepared machine surface (using a tool kit that can be re-sharpened for multiple installations) with an adhesive was selected. The adhesive mounted target facilitates vibration transfer, and the

full frequency range of the accelerometer can be utilized. Another advantage to the adhesive mounted target is the machine surface does not have to be drilled and tapped. A flat mounting target with a threaded hole was selected for this function.

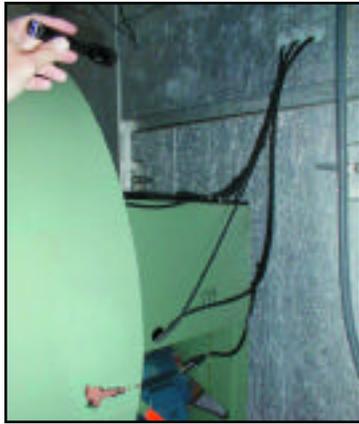
Figure 4 - Cables should be tied together so they cannot be damaged by rotating equipment, and should exit from the air handler unit in a centralized location.

Cables should be tied together so they cannot be damaged by rotating equipment, and should exit from the air handler unit in a centralized location (Figure 4).

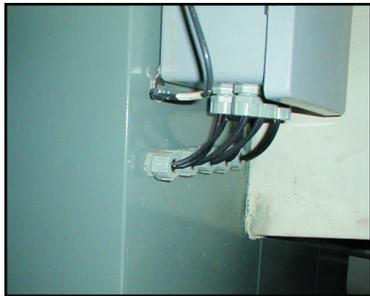
Figure 5 - One option used for this was to drill a hole in the side of the housing for installation of a cord grip and then seal it upon installation with silicone RTV.

Depending on the application and location of the fan-motor set, some units are under pressure and some create a vacuum. Cables exiting the air handling unit enclosure must be properly sealed to prevent air from escaping from the unit (which reduces unit efficiency), or to prevent unconditioned and possibly contaminated air from entering the unit. One option used for this was to drill a hole in the side of the housing for installation of a cord grip (Figure 5), and then seal it upon installation with silicone RTV. This maintained the integrity of the

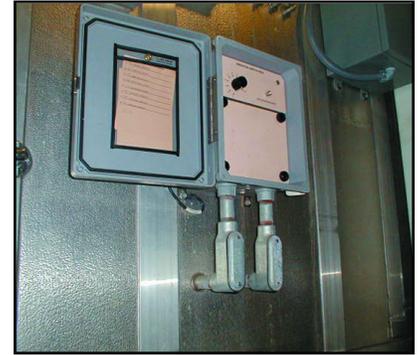
Figure 6 - Another option is to mount a conduit fitting to the side of the housing and run the wires through conduit.

air-tight seal. Another option is to mount a conduit fitting to the side of the housing (Figure 6) and run the wires through conduit.
